Sentinel R9.1.1 Release Notes

Release Date: February 2019

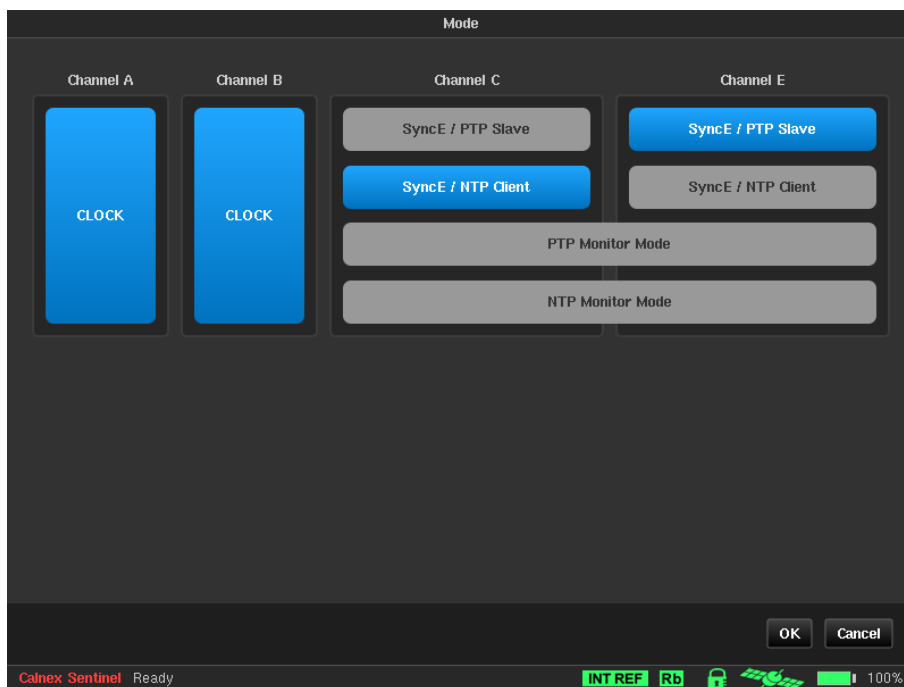
The **Mode** page now allows packet channels to be configured as **SyncE / NTP Client**.

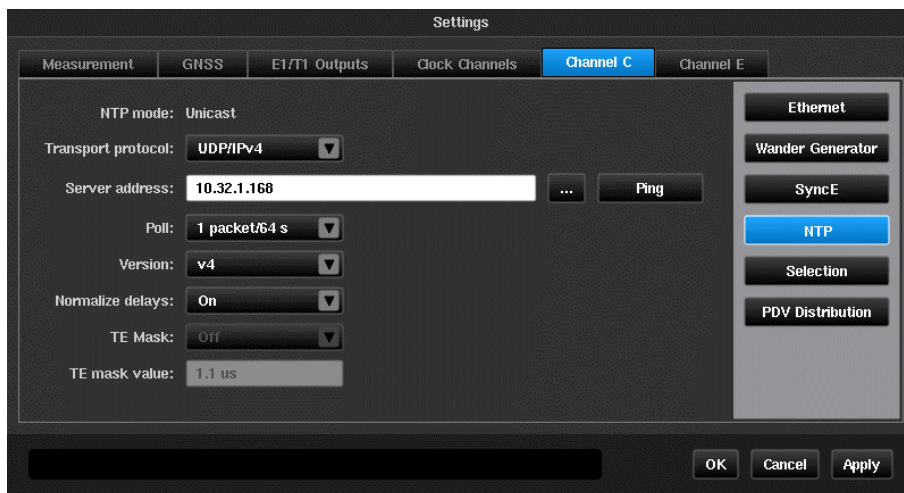
Selecting this option adds a **NTP** page to the **Settings->Channel x** tab.

Each channel can operate independently as PTP slave or NTP client. Selecting either PTP monitor mode or NTP monitor mode will automatically configure the other channel to the corresponding monitor mode.

Sentinel NTP client currently only supports operating in IPv4 unicast mode. Selecting **UDP/IPv6** from the **Protocol Level** dropdown will result in no measurement data being recorded.

The NTP client will start to poll at the rate specified in Poll and will continue to do so unless requested to increase the poll period by the NTP server. The poll rate can be configured as 1 packet every 2^n seconds, where $n=0$ to 17. This gives a maximum poll rate of 1 packet per second and a minimum poll rate of 1 packet every 36.4 hours.

Normalize delays selects whether packet delays are recorded as absolute values or as values relative to the first packet delay. To measure 2 Way Time Error **Normalize delays** should be set to **Off**.

Limits can be set for the 2 Way Time Error and displayed on the graph by setting **TE mask** to **On** and setting **TE mask value** to the test limit.

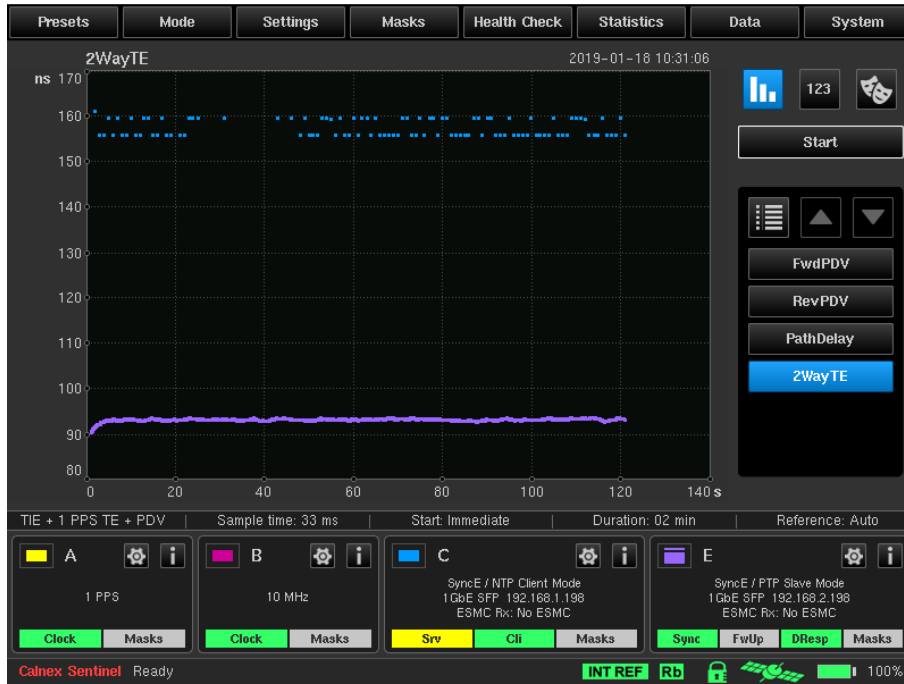
During the test the channel widgets display the status of the NTP message flow.

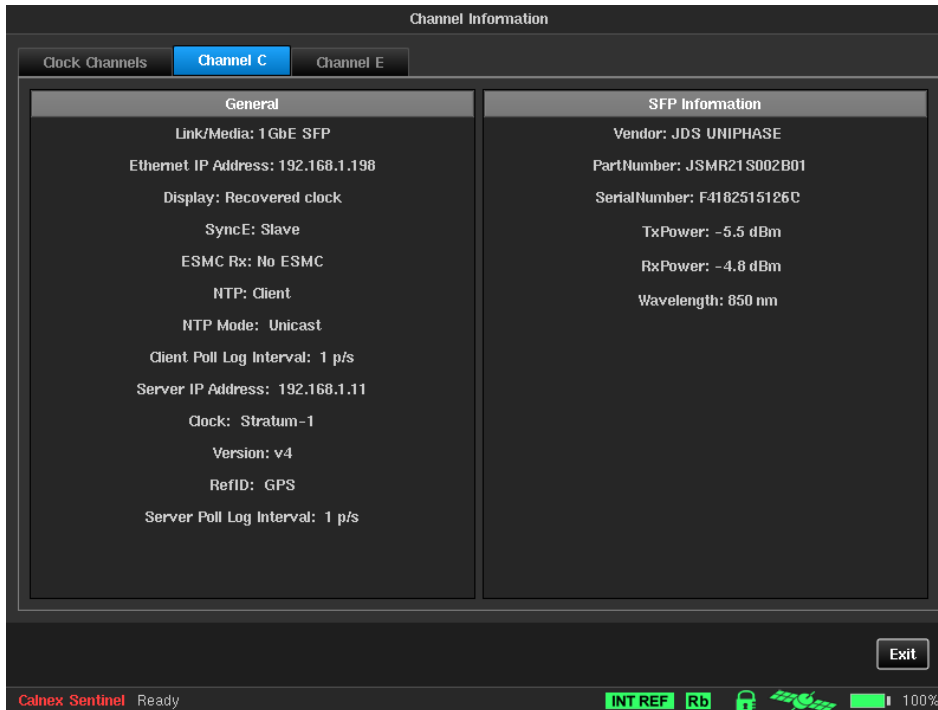
Further details including a decode of the information contained in the Server response can be obtained by pressing the **i** button.

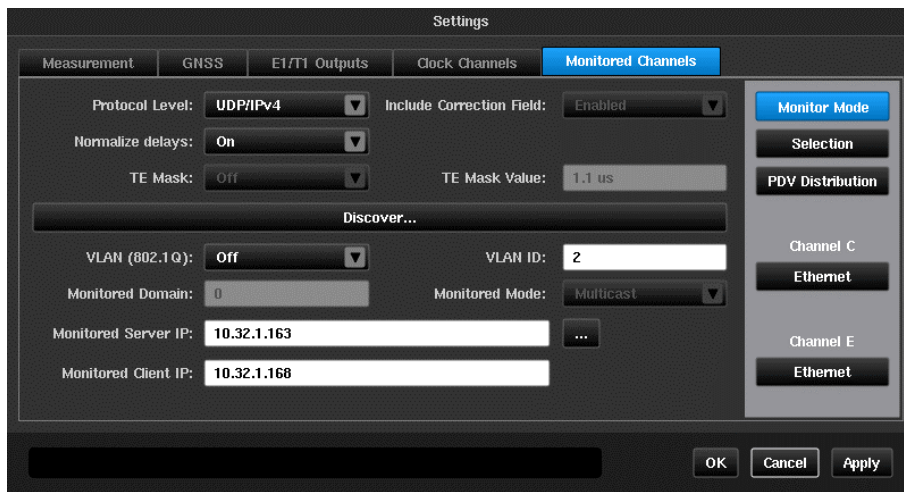
Selecting Monitor Mode operation brings up a single configuration tab on the **Settings** tab.

The flow to be monitored can be selected by pressing the **Discover...** button while the flow is active or manually entered in the **Monitored Server IP** and **Monitored Client IP** boxes.

NOTE: The **Discover...** function may not work at slow poll rates and manual entry will be required.

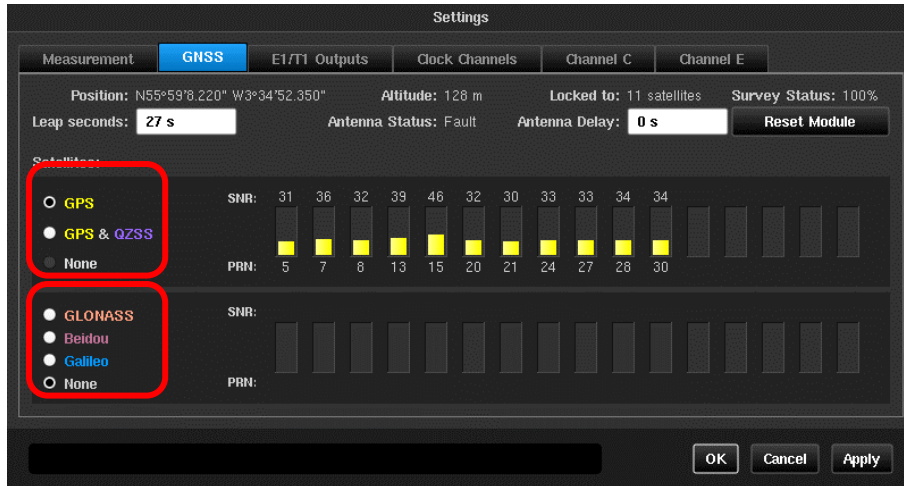
The GNSS module is configured from the Settings->**GNSS** tab.

The top constellation selection determines whether GPS is used and if GPS is selected, whether QZSS is also used. If GPS is not selected then a constellation must be selected in the lower selection area. For multi-constellation operation, Select GPS or GPS and QZSS and a secondary constellation.

Press Apply. This will cause the GNSS module to reset and begin a new site survey using the new constellation(s).

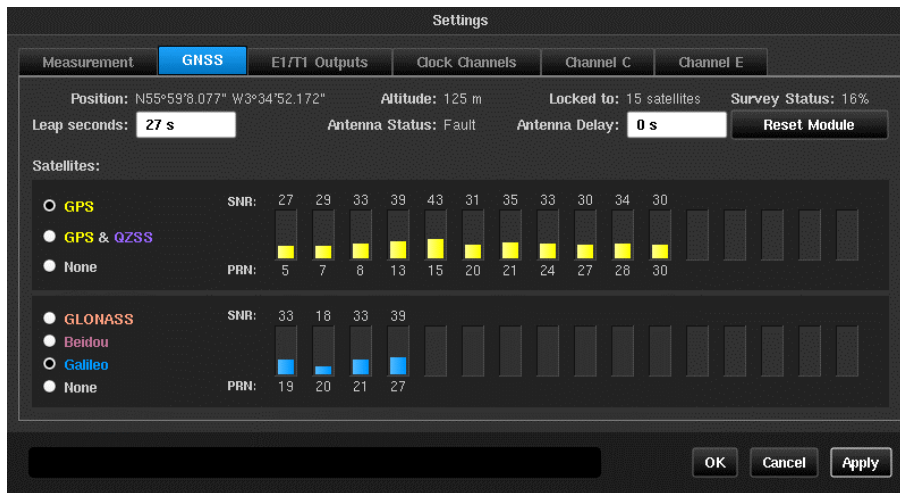
Satellite SNR status is shown in the same colour as the text in the constellation name. The **Locked to** status displays the total number of locked satellites over the multiple selected constellations.

GPS, Galileo and Beidou satellites transmit information that allows Sentinel to calculate the number of leap seconds that have occurred and this is used to determine the offset between TAI and UTC. The **Leap seconds** value is updated automatically whenever this information is received. GLONASS does not transmit leap second information and the **Leap seconds** must be manually entered if the current value is not correct. PTP uses TAI as the time base for its timestamps and if the **Leap seconds** value is incorrect it will show as whole seconds of offset in the FwdPDV, RevPDV and 2WayTE graphs.

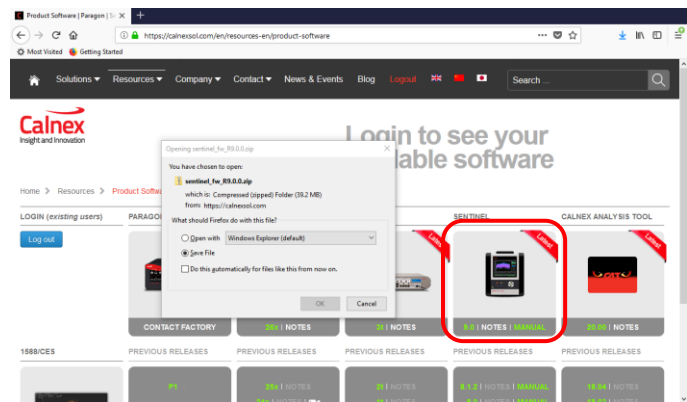
STEP 1

- In the **Resources > Product Software** page at <https://www.calnexsol.com> select the latest Sentinel firmware release.
- Save the file to a local disk.
- Unzip the **sentinel_fw_Rx.y.z.zip** file.
- Copy the **sentinel_fw_Rx.y.z.tar** file from the unzipped **sentinel_fw_Rx.y.z** folder to a blank USB drive.

NOTE: Do not untar the **sentinel_fw_Rx.y.z.tar** file as Sentinel will do this as part of the firmware upgrade.

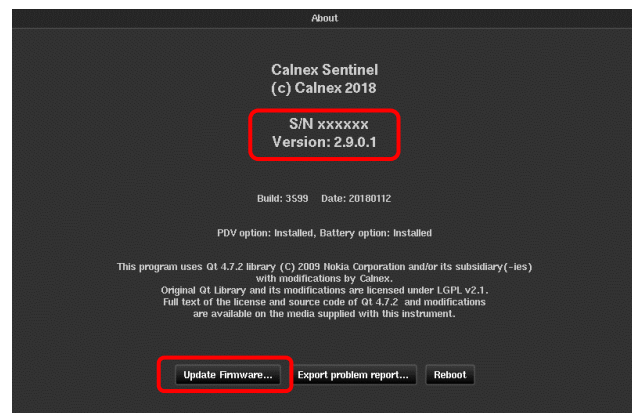
STEP 2

- Power on the Sentinel then plug the USB drive into the USB data port.
- Press the **Systems** tab then select the **About** button. This will show the Sentinel serial number and the current firmware revision.
- Press the **Update Firmware...** button.

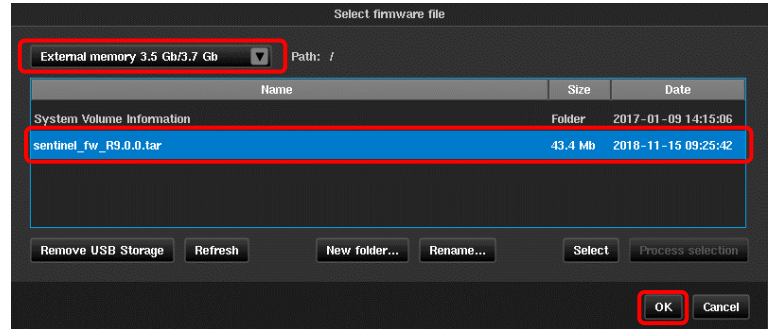
STEP 3

- Select **External memory** as the source.
- Select the **sentinel_fw_Rx.y.z.tar** file.
- Press **OK**.
- Sentinel will begin to extract the firmware.

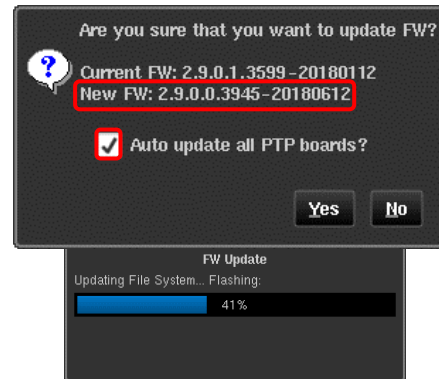
STEP 4

- Verify that the new firmware revision is correct.
 - Ensure that the **Auto update all PTP boards?** check box is selected.
 - Press **Yes**.
- Sentinel will now run through the firmware update, displaying progress on screen. When the upgrade has completed, Sentinel will re-boot automatically.
 - The PTP card(s) firmware version will be checked during re-boot and will be updated if required.

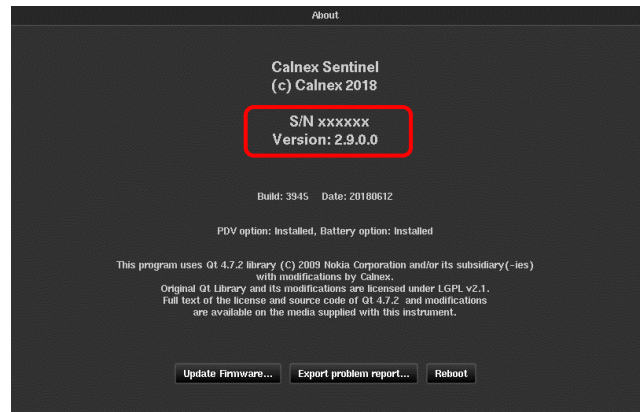
STEP 5

- Verify that the new firmware revision has been installed by checking the information on the **Settings > About** tab.
